# Manhole Inspection Summary

# Manhole # S33EE1003MH

Insp Date: **3/10/07 9:33 AM**

**Location** Address: **3805 39TH ST**

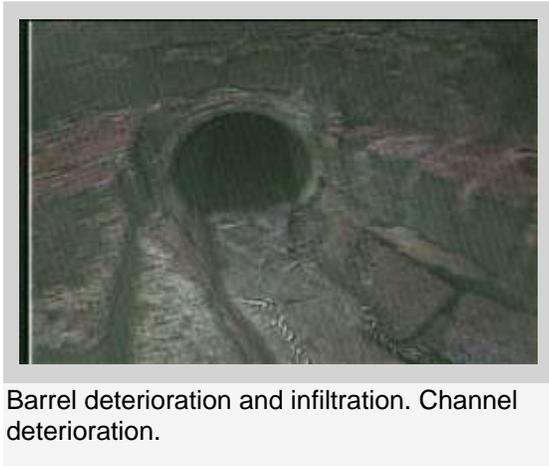
Pipe In @ 9 O'Clock

8 in. Circular Gravity Sewer

Rod and Bar (Angled)

Pipe Material: **Clay**  Pipe Lined

Infiltration: **None** Pipe Seal Cond: **Unknown**
